The CCC Spillway

Presented by the Town of Middleton

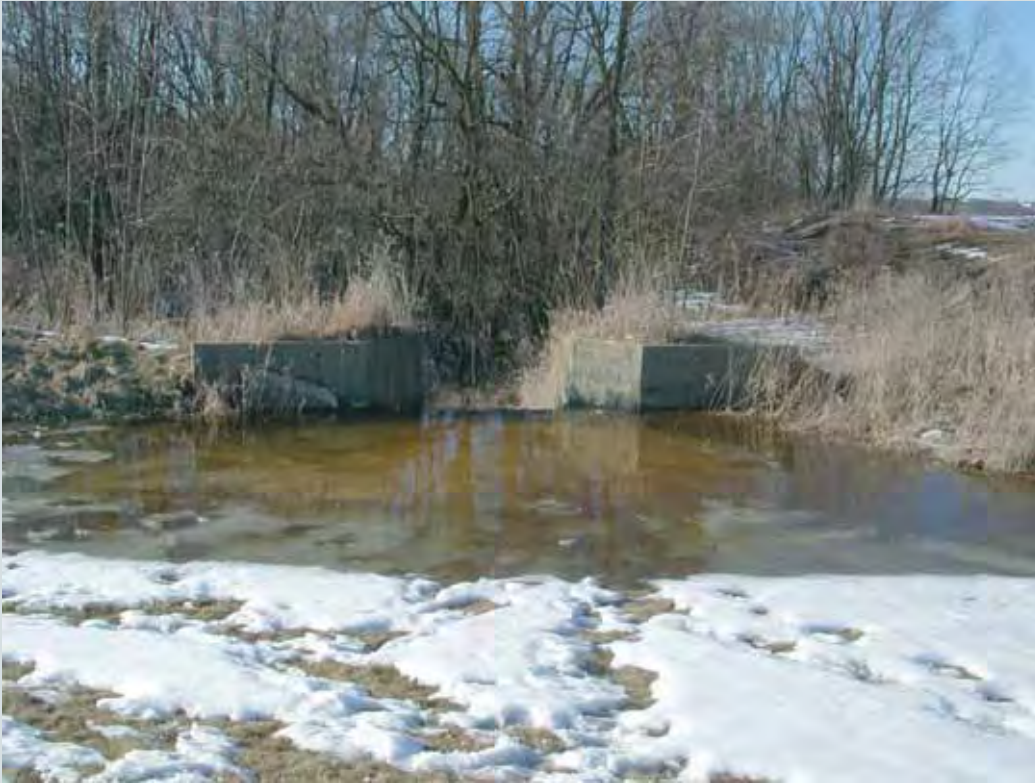
The concrete chute spillway consists of an inlet with wing walls, a vertical curve section, steep-sloped rectangular open channel, velocity check (the triangular concrete piece), stilling basin, and outlet. Flowing water is concentrated and accelerates down the channel then is slowed at the bottom by turbulence created by the velocity check and basin, thereby minimizing soil erosion.

This spillway was built in 1938 by the Civilian Conservation Corps (CCC). The purpose of this reinforced cast-in-place concrete structure is to stop the gully from continuing to cut into the hillside. The spillway is located at the cutting edge (top) of the gully with earthen berms extending from either side of the wingwalls. It has a rectangular channel (conduit) and a stilling basin (before the outlet) to reduce the speed of the water runoff. The basin stores little water, but effectively cuts the velocity of the flow in half, reducing the carrying off of sediment by 64 times!
